MULTICHIP CERAMIC PACKAGE 28

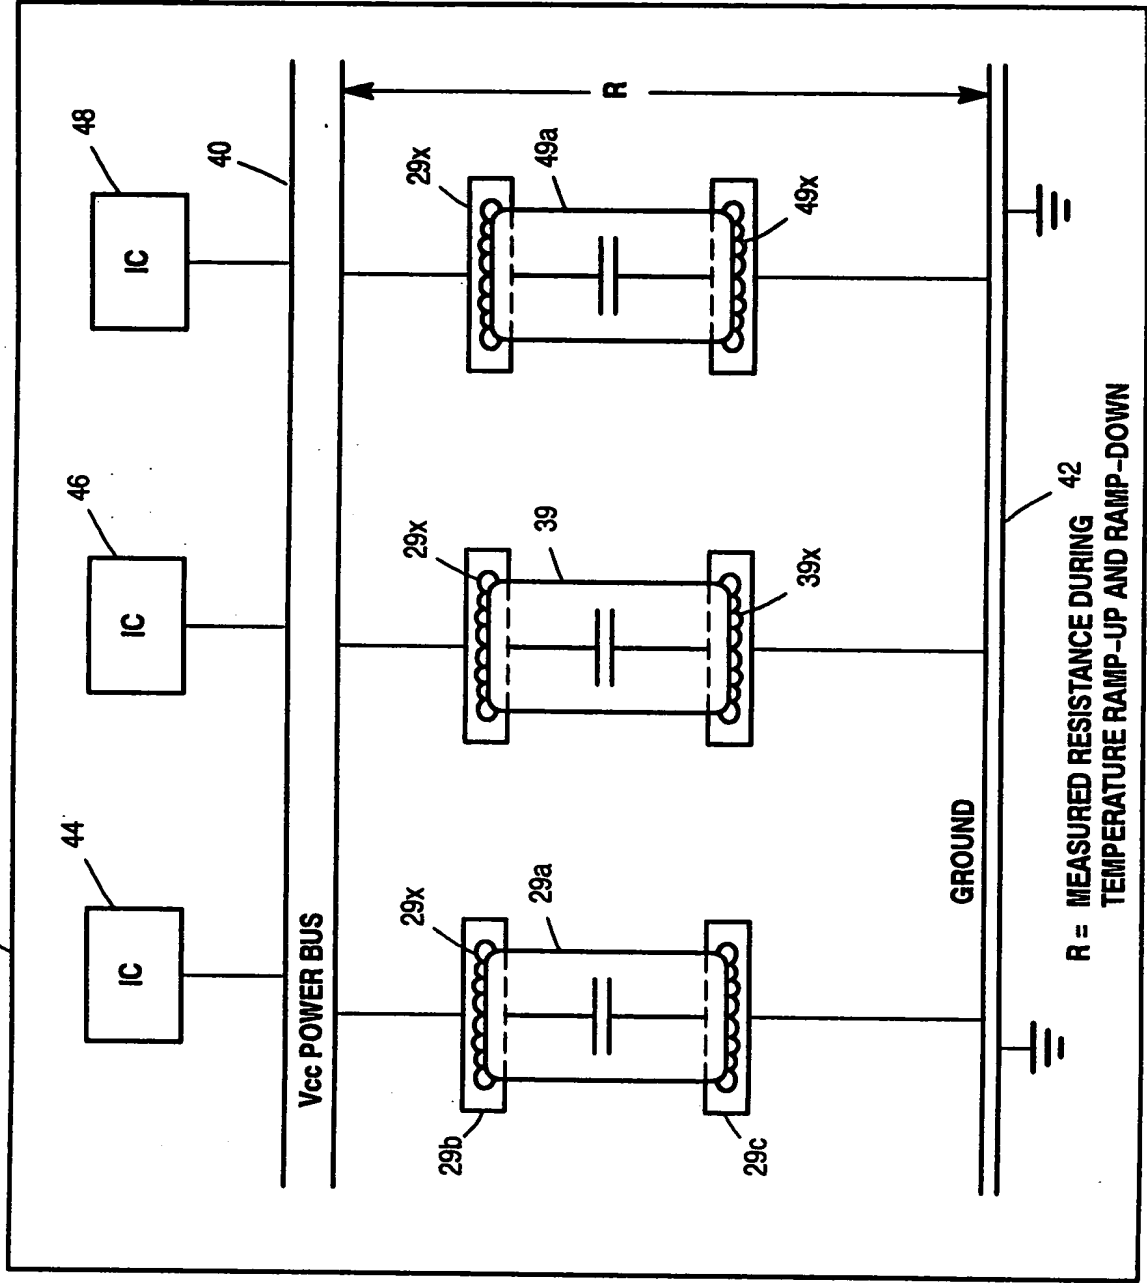
Figure 2B

DEFECTIVE PART WITH INTERMITTENT SHORT (W1008)

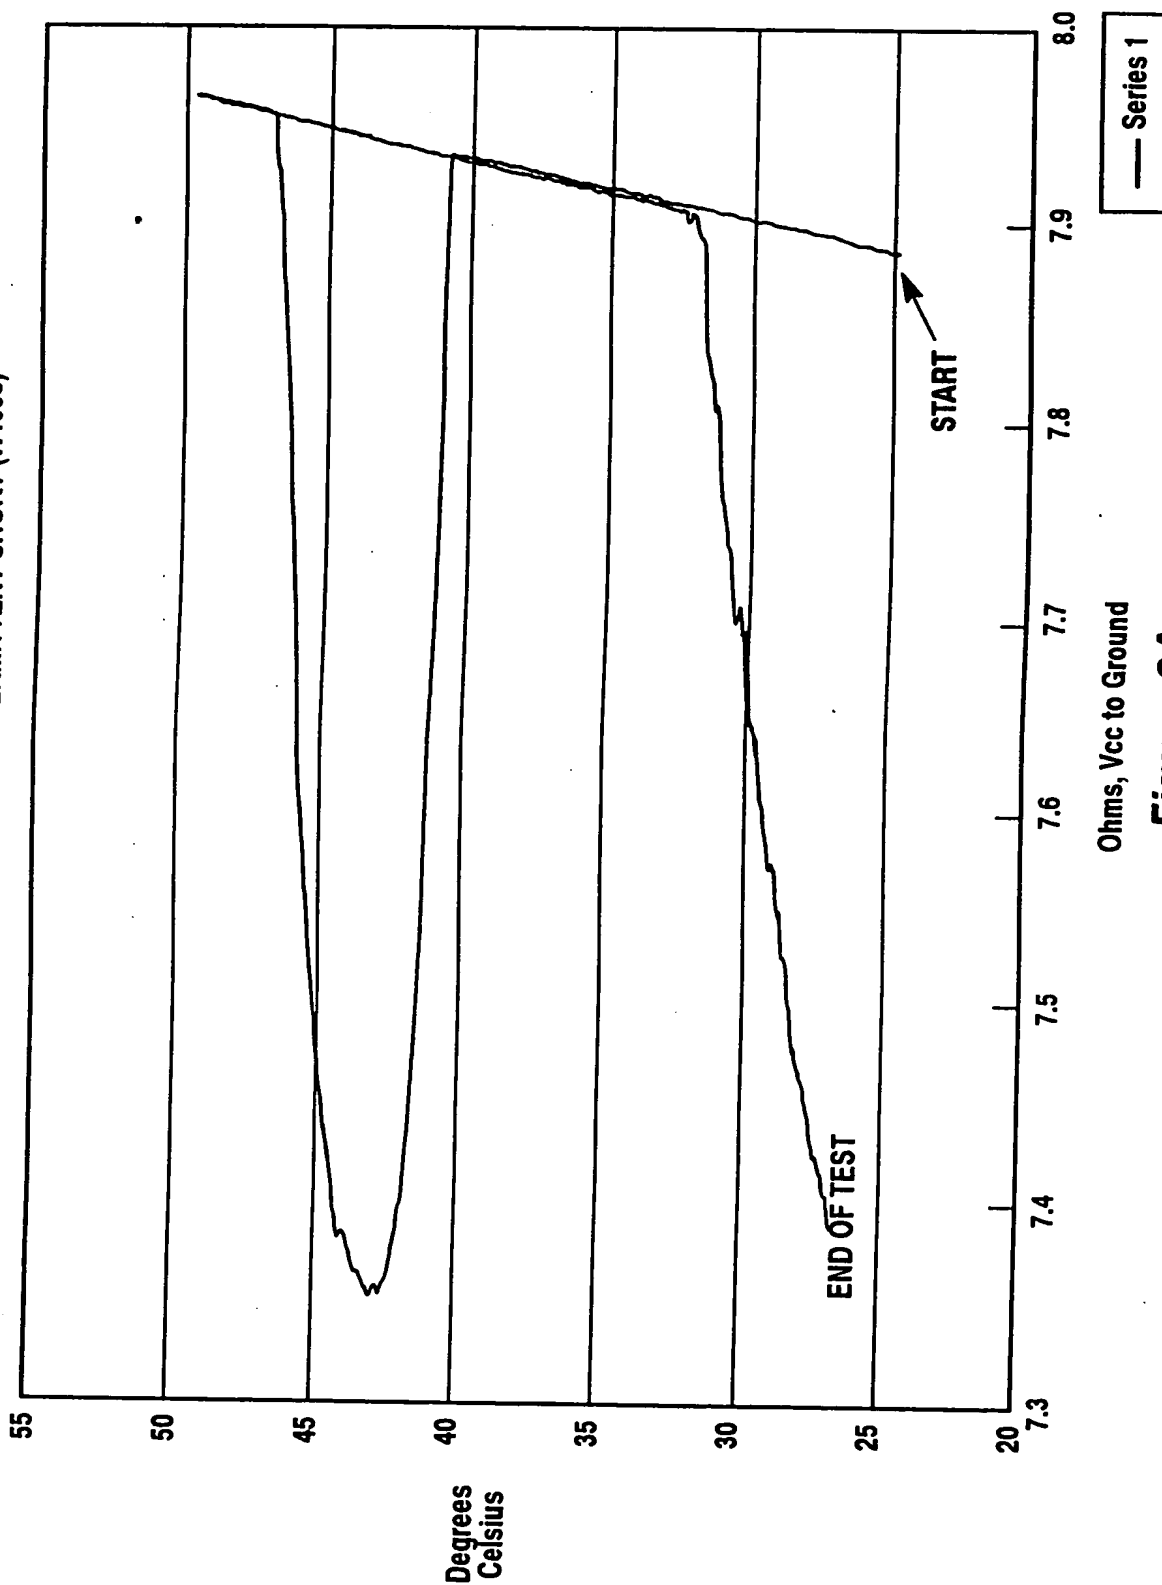
Figure 3A

Ohms, Vcc to Ground

PART W1008 AFTER REMOVAL OF SHORT

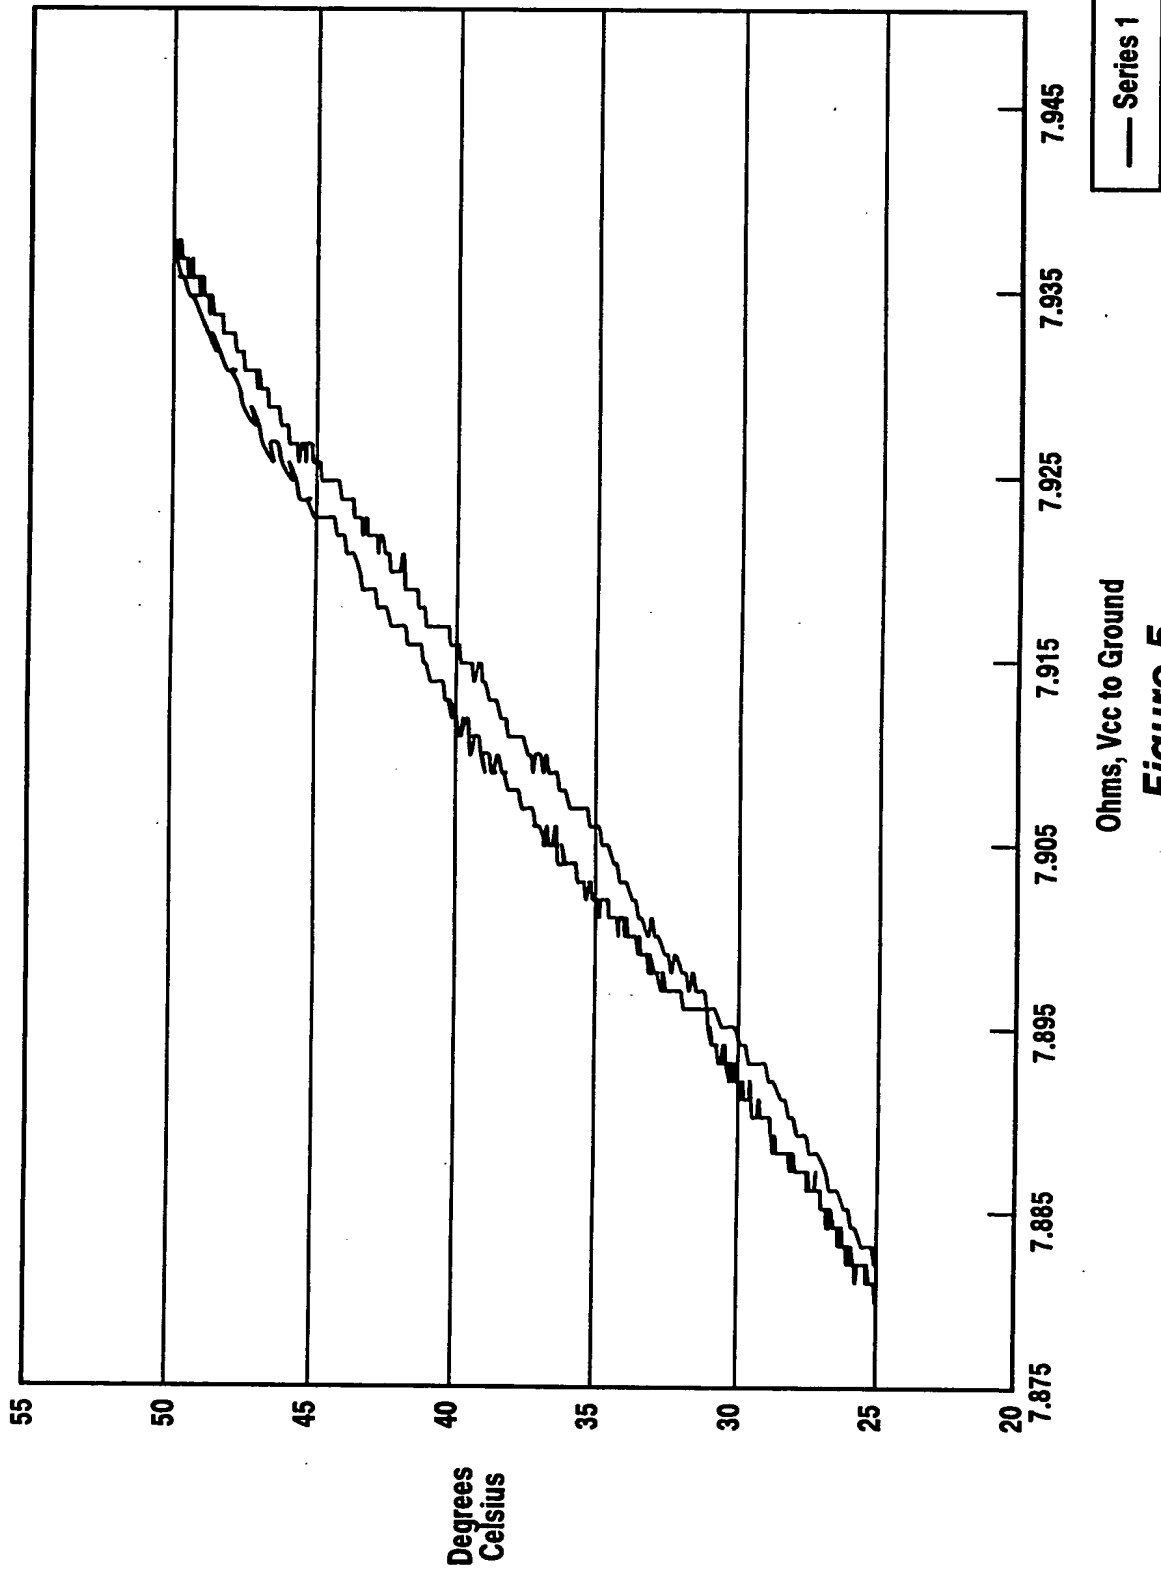
Figure 5

Ohms, Vcc to Ground
